INTERNATIONAL
OIL POLLUTION
COMPENSATION
FUND 1992

92FUND/EXC.34/6/Add.1
20 September 2006
Original: ENGLISH

INCIDENTS INVOLVING THE 1992 FUND

ERIKA INVESTIGATIONS INTO THE CAUSE OF THE INCIDENT

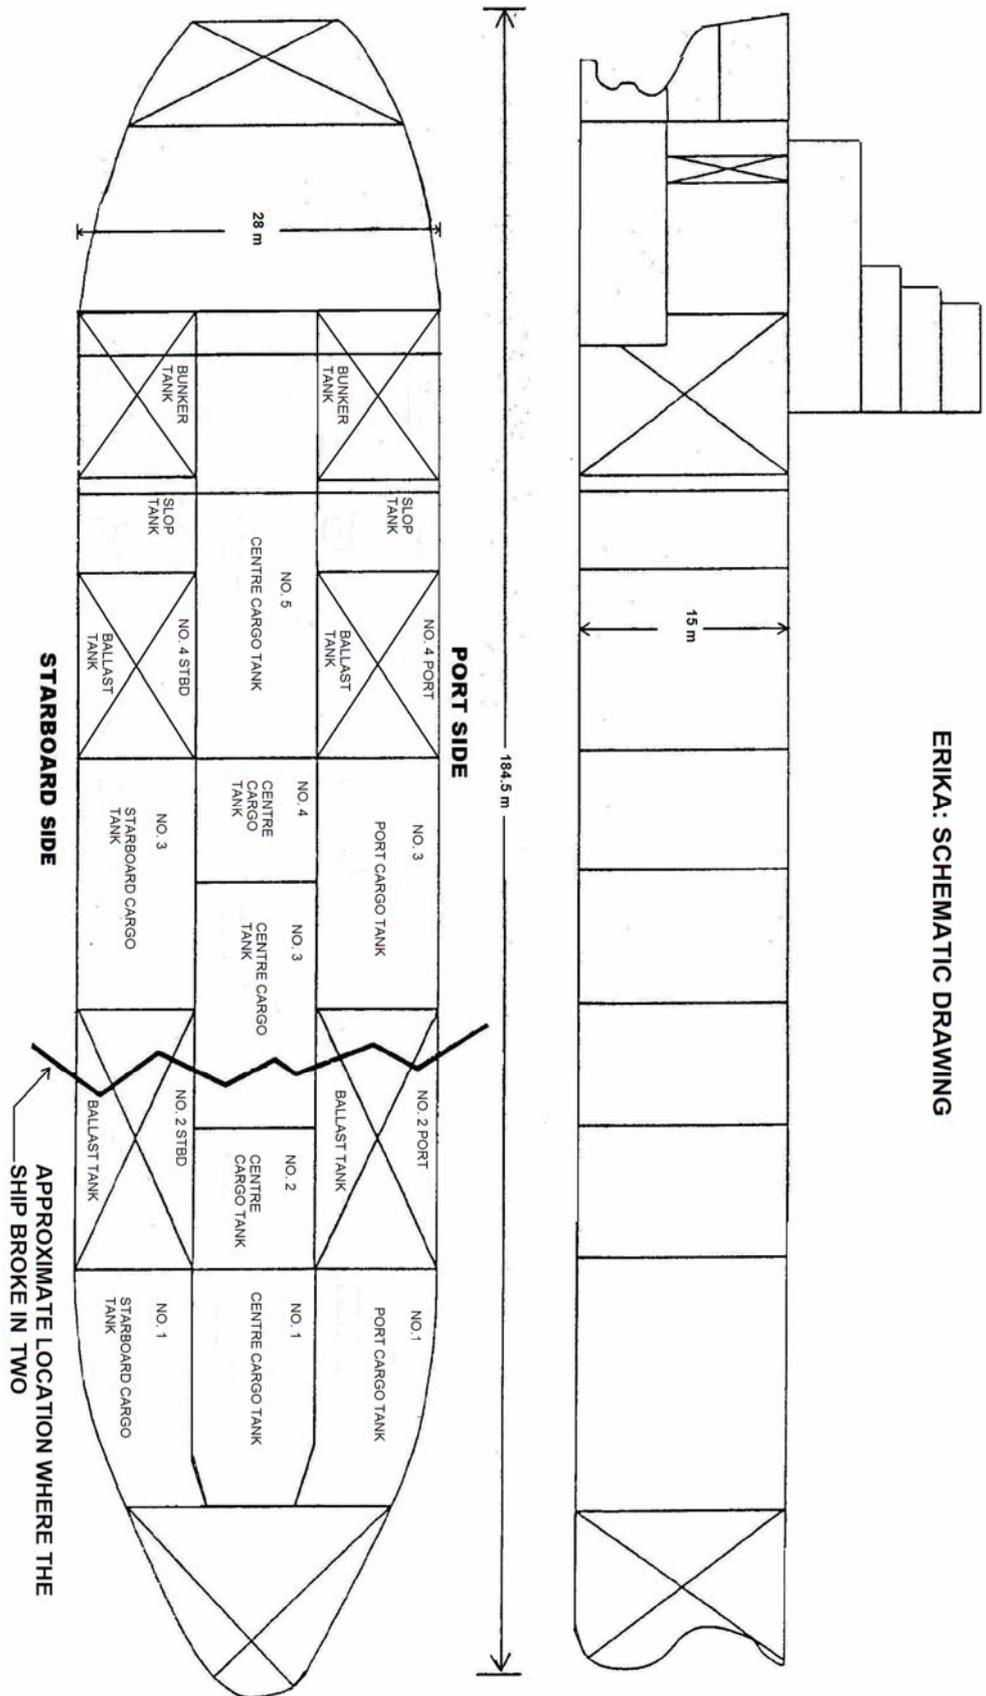
ANNEX

- 1.8 Schematic drawings of the *Erika* are at the Annex.
