INTERNATIONAL  
OIL POLLUTION  
COMPENSATION  
FUND

FUND/EXC.16/3  
4 September 1986

INFORMATION ON AND APPROVAL OF SETTLEMENT OF CLAIMS  
(TANIO INCIDENT)

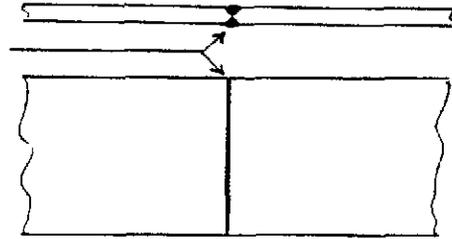
Butt weld,

used for joining one piece to an abutting piece in the same plane, e.g. one shell plate to another shell plate.
